**Flood Control Project Maintenance
Levee Inspections**

Maintenance Issue Types Only, Levee Inspection Report By Mile - Spring 2017

Sutter Maintenance Yard Maintenance Area 0005

Waterway	Bank	Unit Miles	Inspection Start/End	Inspector
Unit No. 01 Butte Creek	Left	15.08	05/02/2017 05/02/2017	Bob Duffey

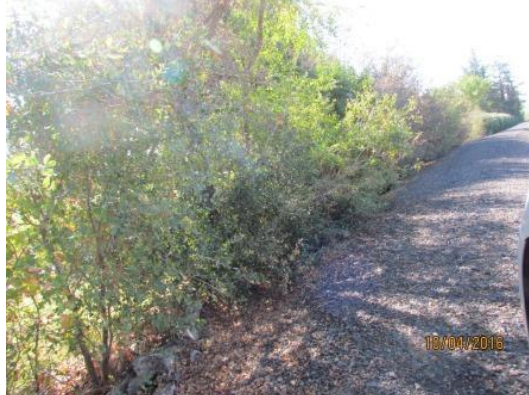
Photo 1 of 1 : SP_2017_MA0005_196_32_20170315_00012.jpg

LM Start	0.58	Rating **	M	Issue No.	32
LM End	0.68	Issue Type +	Ma	Location *	LS
Category	Earthen Levee			GPS Latitude/Longitude	
				Start	End
Item	Trim / Thin Trees			39.690496 °	39.689137 °
				-121.777109 °	-121.776938 °
DWR ID	DWR_MA0005_01_s_2014_32				
Comment Code					
T2 : Thin trees to allow visibility of the ground and room to flood fight.					
Inspector Comment

View of the trees along the landside toe blocking visibility.

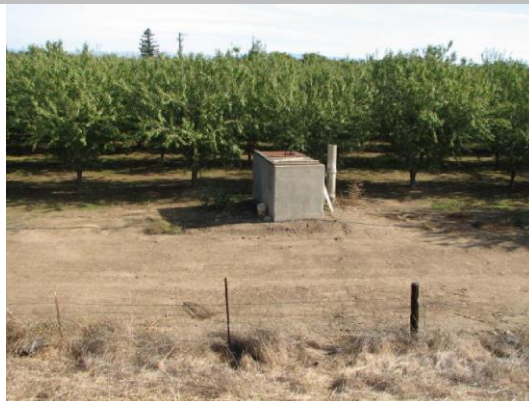
Photo 2 of 3 : UCIP_SP_2017_50843_67930.jpg

FS_ID:50843
 DS_ID:1616
 EP_NO: N/A
 Repair Type: No Action Needed
 Crossing Status: Found
 UCIP Comments: 11/15/2016 Crossing appears to be in good condition. (DWR Sutter Yard- A Freitag) 5/9/2016 Crossing appears to be in good condition. 8/5/2015 WS pipe end is being overgrown by trees and other vegetation. Needs to be cleared back. 12/8/2014 Same as last inspection. 6/11/2014 Same as last inspection. 11/20/2013 Same as last inspection. 5/29/2013 Same as last inspection.
 FIELD_STRUCT_DESC: 24-inch corrugated metal drainage pipe through the levee, 16.5 feet below the crown. Slide gate in a corrugated metal riser on the waterside (WS) slope. Flap gate on the waterside toe. Inlet on the landside (LS) toe, not found. [Additional Reference(s): DWR Levee Log, 1990. USACE Sacramento O&M Manual 516, April 1960 (Station 381+36)].
 FS Date: 11/21/2016 1:34:00 PM

Unable to locate inlet on LS.

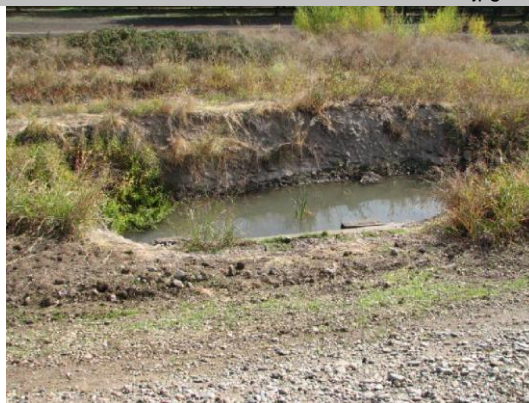
Photo 1 of 3 : UCIP_SP_2017_50847_67939.jpg

FS_ID:50847
DS_ID:1768
EP_NO: N/A
Repair Type: Non-Urgent
Crossing Status: Found
UCIP Comments: 11/15/2016 Abandoned. Needs standpipe cover.
(DWR Sutter Yard- A Freitag) 5/9/2016 Abandoned pipe. Needs a cover for standpipe. 8/5/2015 Abandoned pipes. Need covers made for tops of standpipes to prevent falls. 12/8/2014 Same as last inspection. 6/11/2014 Same as last inspection. 11/19/2013 Same as last inspection. 5/29/2013 Same as last inspection. Land owner said pipes are abandoned and no longer used. Covers should be made for top of standpipe to prevent falls. Pipes should be properly abandoned. 10/30/2012 Pipe 1/2 filled with soil at slide gate on WS. FIELD_STRUCT_DESC: *ABANDONED* 2 of 2: 36-inch corrugated metal drainage pipe through the levee, 11 feet below the crown. Slide gate in a 54-inch corrugated metal riser on the waterside (WS) slope. Concrete "U" shaped headwall on the landside (LS). [Additional Reference(s): DWR Levee Log, 1990. Sacramento O&M Manual 516, April 1960 (Station 470+00)].

Headwall at LS toe.

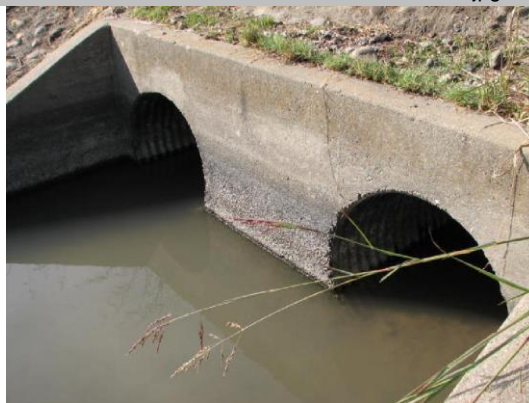
Photo 1 of 2 : UCIP_SP_2017_50848_67941.jpg

FS_ID:50848
DS_ID:1620
EP_NO: N/A
Repair Type: Non-Urgent
Crossing Status: Found
UCIP Comments: 11/15/2016 Abandoned. Needs cover for the standpipe. (DWR Sutter Yard- AFreitag)5/9/2016 Abandoned pipe. Needs a cover for the standpipe.8/5/2015 Abandoned crossing. Covers need to be made for tops of standpipes to prevent falls.12/8/2014 Same as last inspection.6/11/2014 Same as last inspection.11/19/2013 Same as last inspection.5/29/2013 Same as last inspection. Land owner said pipes are abandoned and no longer used. Covers should be made for top of standpipe to prevent falls. Pipes should be properly abandoned.10/30/2012 Pipe 1/2 filled with soil at slide gate end.
FIELD_STRUCT_DESC: *ABANDONED* 1 of 2: 36-inch drainage pipe through the levee, 11 feet below the crown. Slide gate in a 54-inch corrugated metal riser on the waterside (WS) slope. Concrete "U" headwall on the landside (LS). [Additional Reference(s): DWR Levee Log, 1990. Sacramento O&M Manual 516, April 1960 (Station 470+00)].

Headwall at LS toe.

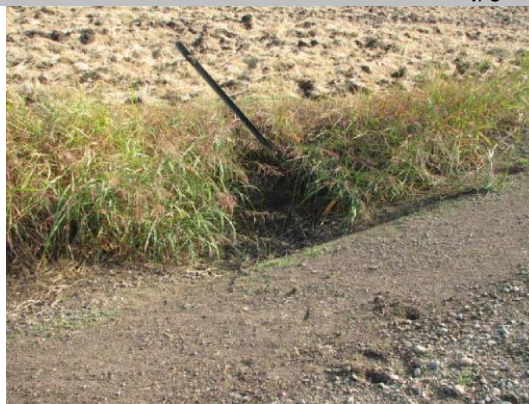
Photo 1 of 2 : UCIP_SP_2017_50864_67970.jpg

FS_ID:50864
DS_ID:1628
EP_NO: N/A
Repair Type: Non-Urgent
Crossing Status: Found
UCIP Comments: 11/15/2016 Appears abandoned and should be done so properly. (DWR Sutter Yard- AFreitag)5/11/2016 Possibly an abandoned crossing. LS inlet was over 50% buried and nothing was found on the WS.8/4/2015 LS pipe end filled about 50% with soil and WS pipe end is buried.12/8/2014 Same as last inspection.6/11/2014 Same as last inspection.11/19/2013 Same as last inspection.5/29/2013 Same as last inspection.10/30/2012 Pipe filled with soil and outlet/appurtenances are buried.
FIELD_STRUCT_DESC: *ABANDONED* 24-inch corrugated metal drainage pipe through the levee, 8.5 feet below the crown. Flap gate on the waterside (WS). Concrete "U" shaped headwall on the landside (LS) toe. [Additional Reference(s): DWR Levee Log, 1990. Sacramento O&M Manual 515, April 1955 (Station 576+72), USACE As-built Drawings 50-4-2637, Exhibit B, Sheet 2, April 1950 (station 576+72.4)].

Headwall at LS toe.

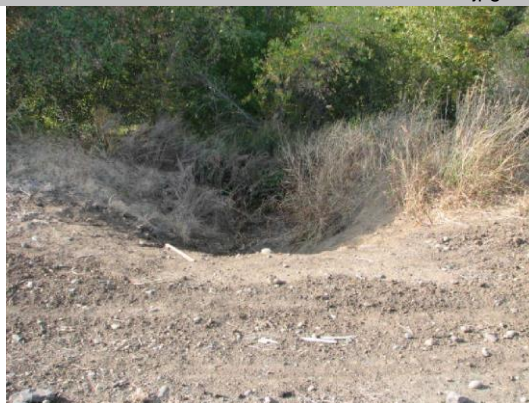
Photo 1 of 3 : UCIP_SP_2017_50865_67973.jpg

FS_ID:50865
DS_ID:1629
EP_NO: N/A
Repair Type: Non-Urgent
Crossing Status: Found
UCIP Comments: 11/15/2016 LS inlet was unburied and entire pipe is about 25% full of soil. WS flapgate was shut and partially buried. (DWR Sutter Yard- A Freitag) 5/11/2016 WS flap gate was about 50% buried and LS was 100% buried. Appears to be an abandoned crossing. 8/4/2015 WS flap gate is partially buried by soil and being overgrown with vegetation. LS pipe end was underwater and suspected to still be completely buried with soil. 12/8/2014 Same as last inspection. 6/11/2014 Same as last inspection. 11/19/2013 Same as last inspection. 5/29/2013 Same as last inspection. 10/30/2012 Pipe filled with soil.
FIELD_STRUCT_DESC: 24-inch corrugated metal drainage pipe through the levee, 9.3 feet below the crown. Flap gate on the waterside (WS). Concrete headwall at the landside (LS) and the WS toes.
[Additional Reference(s): DWR Levee Log, 1990. Sacramento O&M 515, April 1955 (Station 609+79). USACE As-Built Drawing 50-4-2637, Exhibit B, Sheet 3, April 1950 (Station 609+78.5)].

Outlet at WS toe.

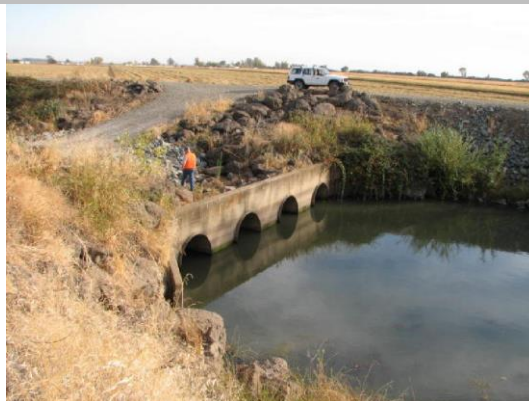
Photo 1 of 2 : UCIP_SP_2017_50869_67979.jpg

WS of pipe crossing

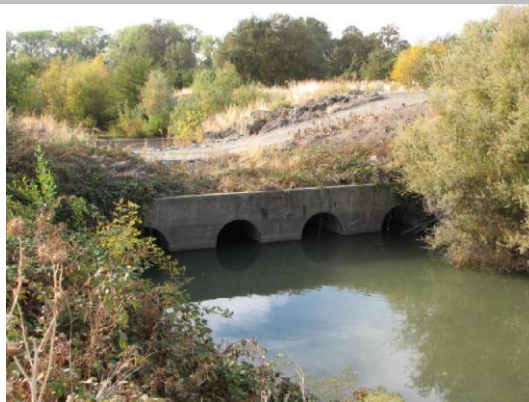
Photo 2 of 2 : UCIP_SP_2017_50869_67978.jpg

LS of pipe crossing.

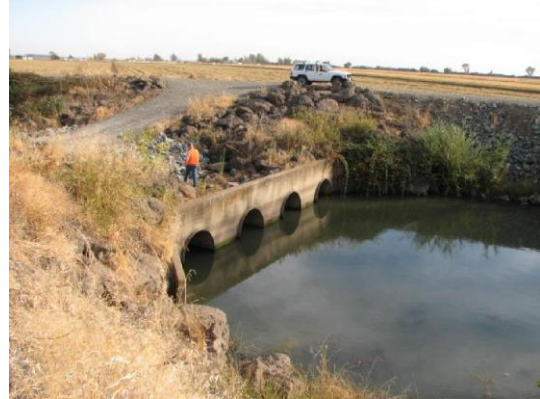
Photo 1 of 2 : UCIP_SP_2017_50871_67982.jpg

WS of crossing.

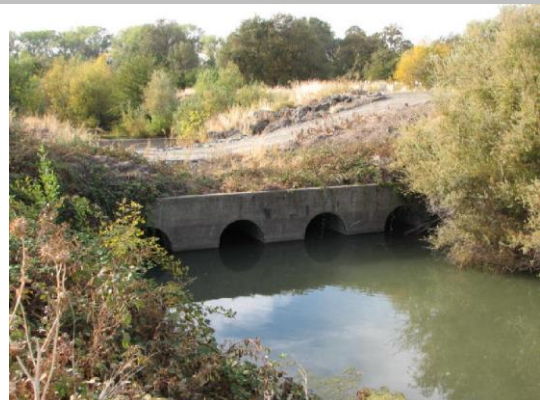
Photo 2 of 2 : UCIP_SP_2017_50871_67983.jpg

LS of crossing.

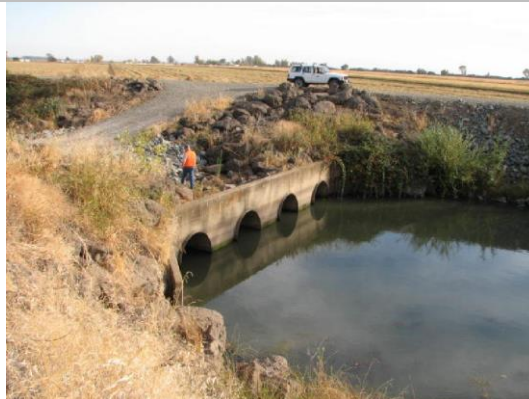
Photo 1 of 2 : UCIP_SP_2017_50872_67985.jpg

WS of crossing.

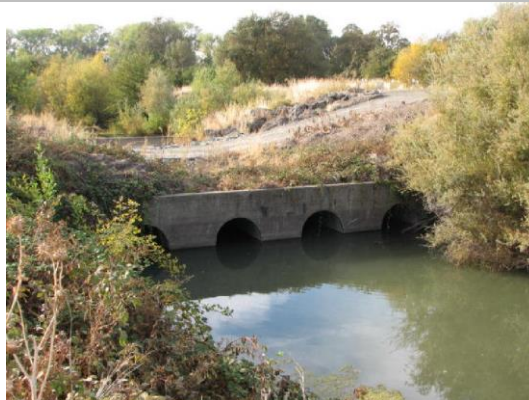
Photo 2 of 2 : UCIP_SP_2017_50872_67984.jpg

LS of crossing.

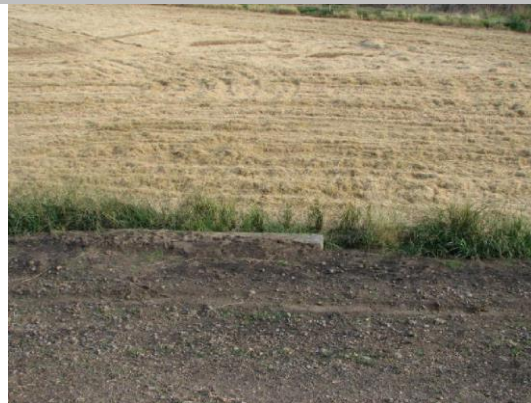
Photo 1 of 2 : UCIP_SP_2017_50875_67991.jpg

Concrete headwall at LS toe.

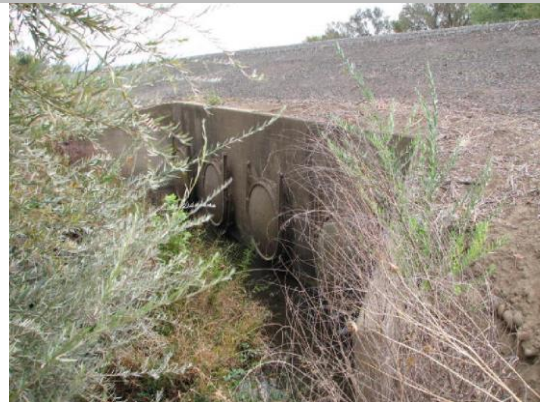
Photo 1 of 2 : UCIP_SP_2017_50882_68007.jpg

Comment Code						
Inspector Comment						
FS_ID:50882 DS_ID:1636 EP_NO: N/A Repair Type: No Action Needed Crossing Status: Found UCIP Comments: 11/15/2016 Crossing appears to be in good condition. (DWR Sutter Yard- A/Freitag)5/11/2016 Crossing appears to be in good condition.8/4/2015 Crossing appears in good condition. No noticeable issues to report.6/11/2014 Same as last inspection.11/19/2013 Same as last inspection.5/29/2013 Same as last inspection. FIELD_STRUCT_DESC: 1 of 4: 54-inch corrugated metal drainage pipe through the levee, 13.5 feet below the crown. Flap gate on the waterside (WS). Concrete headwall on landside (LS) and WS toes. [Additional Reference(s): DWR Levee Logs, 1990. USACE Sacramento O&M Manual 515, April 1955 (Station 25+18"A"). USACE As-built Drawing 50-4-2637, Exhibit B, Sheet 4, April 1950 (Station 25+18"A")]. FS Date: 11/21/2016 2:29:11 PM

WS headwall and flap gates at WS toe.

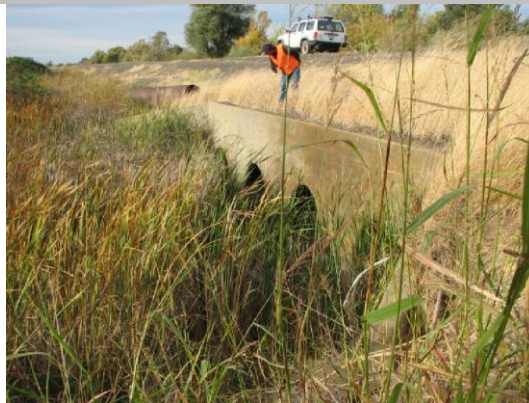
Photo 2 of 2 : UCIP_SP_2017_50882_68006.jpg

LS intake headwall.

Comment Code					
Inspector Comment					
FS_ID:50882 DS_ID:1636 EP_NO: N/A Repair Type: No Action Needed Crossing Status: Found UCIP Comments: 11/15/2016 Crossing appears to be in good condition. (DWR Sutter Yard- A Freitag) 5/11/2016 Crossing appears to be in good condition. 8/4/2015 Crossing appears in good condition. No noticeable issues to report. 6/11/2014 Same as last inspection. 11/19/2013 Same as last inspection. 5/29/2013 Same as last inspection. FIELD_STRUCT_DESC: 1 of 4: 54-inch corrugated metal drainage pipe through the levee, 13.5 feet below the crown. Flap gate on the waterside (WS). Concrete headwall on landside (LS) and WS toes. [Additional Reference(s): DWR Levee Logs, 1990. USACE Sacramento O&M Manual 515, April 1955 (Station 25+18"A"). USACE As-built Drawing 50-4-2637, Exhibit B, Sheet 4, April 1950 (Station 25+18"A")]. FS Date: 11/21/2016 2:29:11 PM

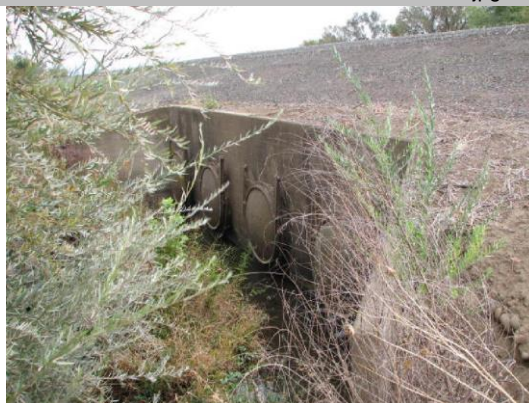
Photo 1 of 2 : UCIP_SP_2017_50883_68009.jpg

Headwall and flap gates at WS toe.

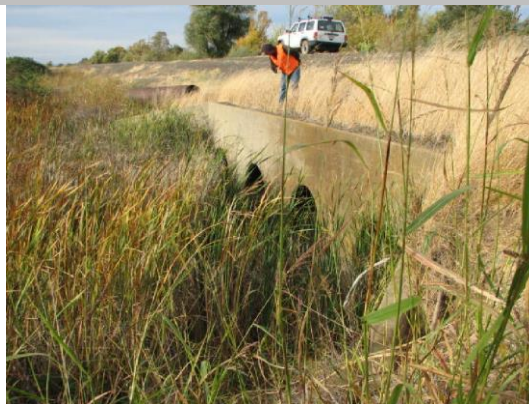
Photo 2 of 2 : UCIP_SP_2017_50883_68008.jpg

Headwall at LS toe.

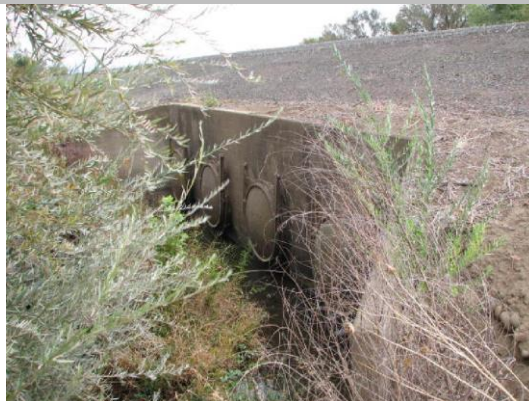
Photo 1 of 2 : UCIP_SP_2017_50884_68011.jpg

Headwall and flap gates at WS toe.

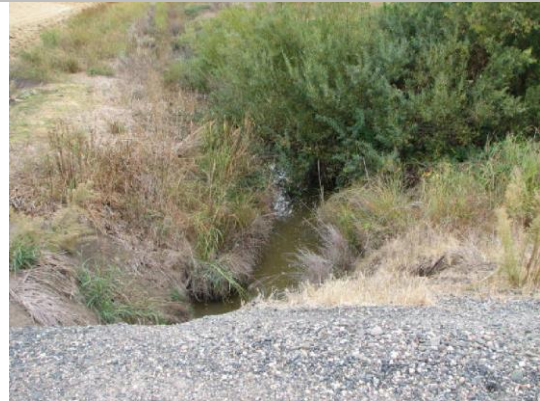
Photo 1 of 3 : UCIP_SP_2017_50886_68017.jpg

Drainage canal on LS toe.

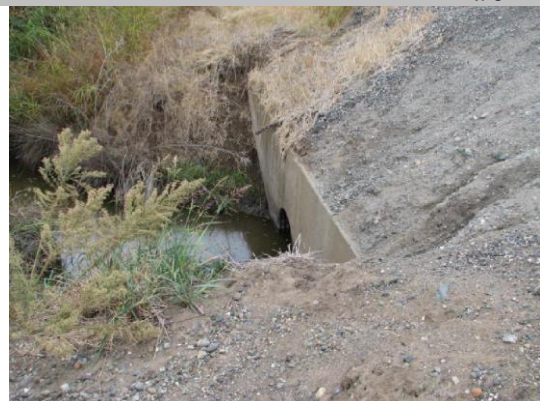
Photo 2 of 3 : UCIP_SP_2017_50886_68016.jpg

Concrete headwall on LS toe.

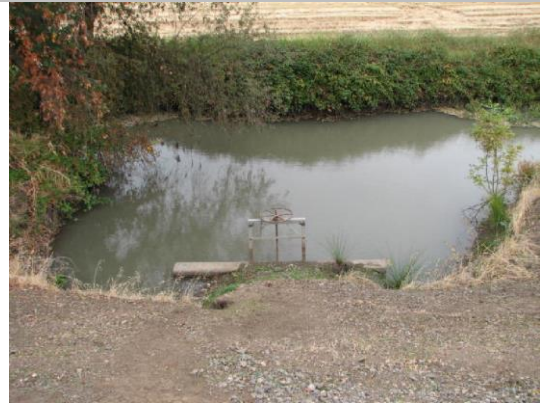
Photo 1 of 3 : UCIP_SP_2017_50904_68498.jpg

FIELD_STRUCT_DESC: 36-inch corrugated metal drainage pipe through the levee, 17 feet below the crown. Flap gate on the waterside (WS). Slide gate on the landside (LS) toe. Concrete headwall at both the LS and the WS toes. [Additional Reference(s): DWR Levee Logs, 1990. USACE Sacramento O&M Manual 515 (Station 902+50). USACE As-built Drawing 50-4-2637, Exhibit B, Sheet 5, April 1950 (Station 902+50)].
FS Date: 11/22/2016 9:20:46 AM

Concrete headwall and slide gate on LS toe.

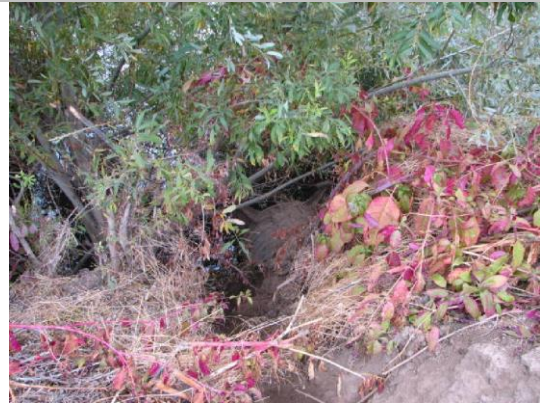
Photo 2 of 3 : UCIP_SP_2017_50904_68497.jpg

Flap gate on WS slope.

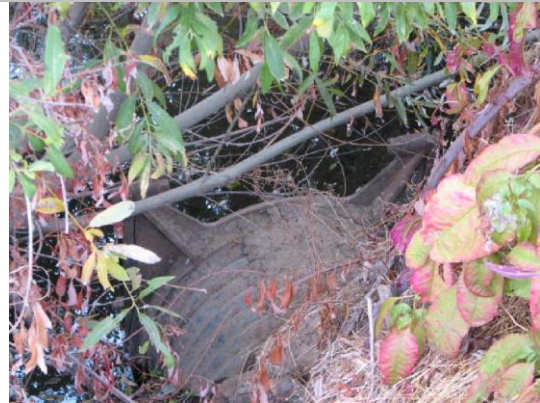
Photo 3 of 3 : UCIP_SP_2017_50904_68496.jpg

Flap gate on WS slope.

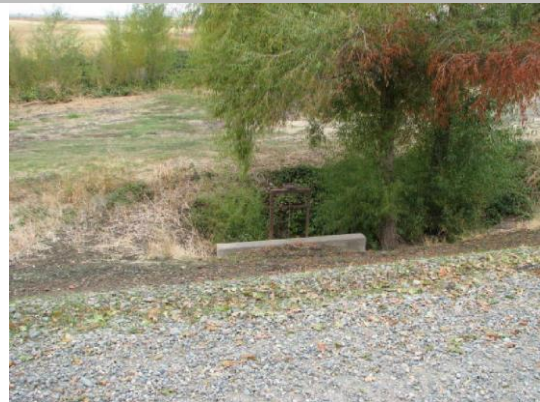
Photo 1 of 3 : UCIP_SP_2017_50906_68064.jpg

Comment Code					
Inspector Comment					
FS_ID:50906 DS_ID:1647 EP_NO: N/A Repair Type: No Action Needed Crossing Status: Found UCIP Comments: 11/14/2016 Crossing appears to be in good condition. (DWR Sutter Yard- A Freitag) 5/23/2016 Crossing appears to be in good condition. 7/28/2015 Pipe appears in good condition. No noticeable issues to report. 6/6/2013 Same as last inspection. 11/12/2013 Same as last inspection. 6/04/2014 Same as last inspection. 11/25/2014 Same as last inspection. FIELD_STRUCT_DESC: 30-inch corrugated metal drainage pipe through the levee, 14.3 feet below the crown. Slide gate on the landside (LS), flap gate on the waterside (WS). Concrete headwall at the LS toe. Concrete splash apron on the WS. [Additional Reference(s): DWR Levee Logs, 1990. USACE Sacramento O&M Manual 515, April 1955 (Station 5+20"A"). USACE As-built Drawing 50-4-2637, Exhibit B, Sheet 4, April 1950 (Station 5+20"A")]. FS Date: 11/22/2016 9:27:49 AM

Concrete headwall and slide gate at LS toe.

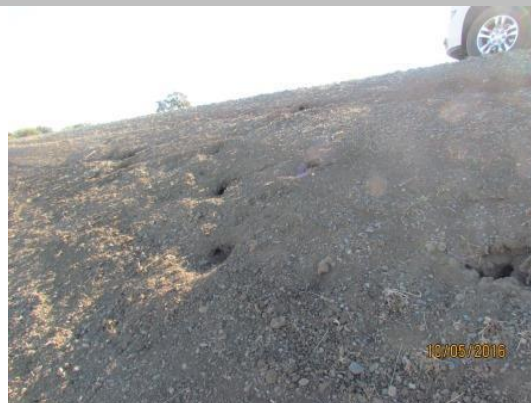
Photo 1 of 1 : SP_2017_MA0005_197_51_20170315_00026.jpg

LM Start	4.91	Rating **	M	Issue No.	51
LM End	4.91	Issue Type +	Ma	Location *	LS
Category	Earthen Levee			GPS Latitude/Longitude	
				Start	End
Item	Animal Control			39.571258 °	39.571258 °
				-121.818045 °	-121.818045 °
DWR ID	DWR_MA0005_02_f_2016_51				
Comment Code					
A3 : No rodents visible, but rodent burrows visible; need to backfill and compact or grout burrows.					
Inspector Comment

View of the rodent holes along the landside slope.

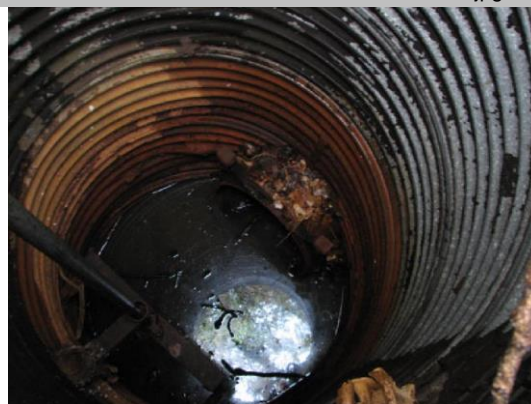
Photo 1 of 2 : UCIP_SP_2017_50920_68105.jpg

Comment Code					
Inspector Comment					
FS_ID:50920 DS_ID:1650 EP_NO: N/A Repair Type: Non-Urgent Crossing Status: Found UCIP Comments: 11/14/2016 Abandoned. (DWR Sutter Yard-AFreitag)5/23/2016 Abandoned7/28/2015 Abandoned- still cannot locate a LS ans WS pipe end.11/25/2014 Same as last inspection.6/04/2014 Same as last inspection.11/12/2013 Same as last inspection.6/6/2013 Same as last inspection.10/31/2012 Appears abandoned. Unable to locate outfall on WS. Unable to locate inlet on LS. FIELD_STRUCT_DESC: *ABANDONED* 24-inch corrugated metal drainage pipe through the levee, 12.5 feet below the crown. Slide gate and flap gate in a 56-inch corrugated metal riser on the waterside (WS) berm. Flap gate on the WS. [Additional Reference(s): DWR Levee Logs, 1990. USACE Sacramento O&M Manual 515, April 1955 (Station 688+40). USACE As-built Drawing 50-4-2637, Exhibit B, Sheet 3, April 1950 (Station 688+40)]. FS Date: 11/22/2016 10:09:44 AM

Slide gate and flap gate inside CMP riser on WS berm.

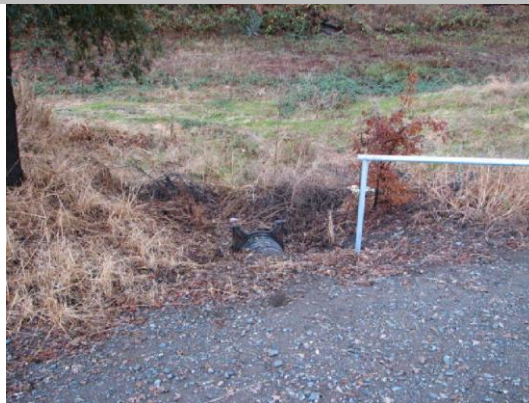
Photo 1 of 3 : UCIP_SP_2017_50927_68122.jpg

Flap gate on WS toe.

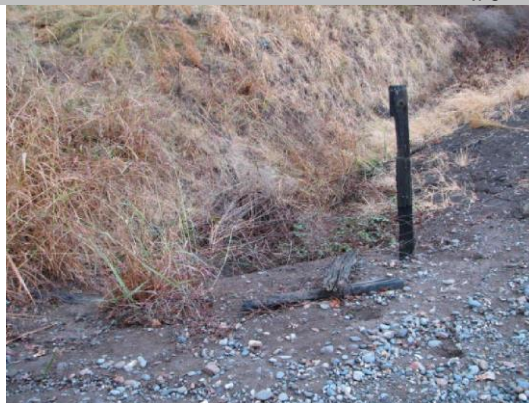
Photo 2 of 3 : UCIP_SP_2017_50927_68121.jpg

Headwall on LS toe.

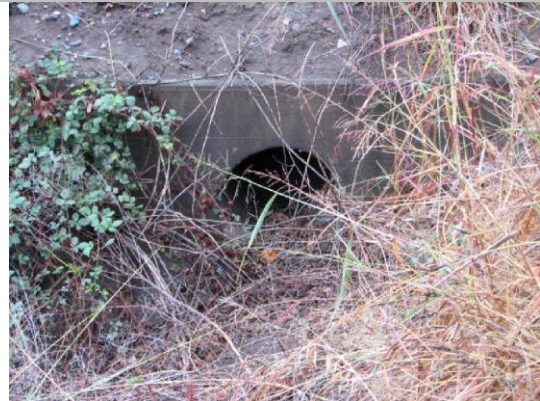
Photo 3 of 3 : UCIP_SP_2017_50927_68120.jpg

Comment Code					
Inspector Comment					
FS_ID:50927 DS_ID:1654 EP_NO: N/A Repair Type: No Action Needed Crossing Status: Found UCIP Comments: 11/14/2016 Crossing appears to be in good condition. (DWR Sutter Yard- A Freitag)5/23/2016 Crossing appears to be in good condition.7/28/2015 Crossing appears in good condition. No noticeable issues to report.11/24/2014 Same as last inspection.6/04/2014 Same as last inspection.11/12/2013 Same as last inspection.6/6/2013 Same as last inspection. FIELD_STRUCT_DESC: 24-inch corrugated metal drainage pipe through the levee, 9.4 feet below the crown. Flap gate on the waterside (WS). Concrete headwall at both landside (LS) and WS toes. [Additional Reference(s): DWR Levee Logs, 1990. USACE Sacramento O&M Manual 515, April 1955 (Station 627+00). USACE As-built Drawing 50-4-2637, Exhibit B, Sheet 3, April 1950 (Station 627+00)]. FS Date: 11/22/2016 10:17:04 AM

Headwall on LS toe.

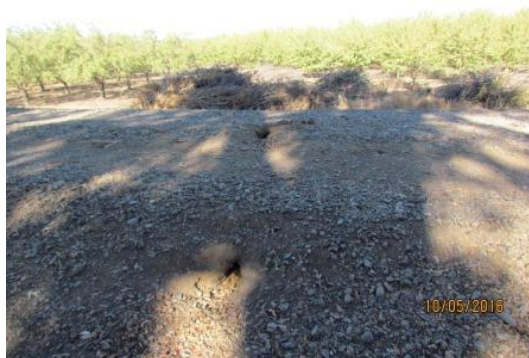
Photo 2 of 2 : SP_2017_MA0005_197_53_20170315_00029.jpg

LM Start	7.74	Rating **	U	Issue No.	53 (cont)	
LM End	7.74	Issue Type +	Ma	Location *	LS	
Category	Earthen Levee			GPS Latitude/Longitude		
				Start		End
Item	Animal Control			39.605088 °		39.605088 °
				-121.788569 °		-121.788569 °
DWR ID	DWR_MA0005_02_f_2016_53					
Comment Code						
A1 : Exterminate rodents and backfill and compact or grout burrows.						
Inspector Comment

View of the rodent holes along the crown and waterside slope.

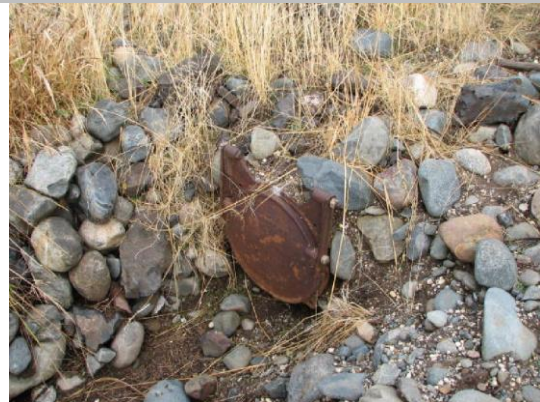
Photo 1 of 2 : UCIP_SP_2017_50930_68129.jpg

Comment Code					
Inspector Comment					
FS_ID:50930 DS_ID:1656 EP_NO: N/A Repair Type: Non-Urgent Crossing Status: Found UCIP Comments: 11/14/2016 LS inlet almost completely full of soil. (DWR Sutter Yard- A Freitag)5/23/2016 LS end is almost completel full of soil.7/28/2015 Pipe is still over 3/4 full of soil. 11/24/2014 Same as last inspection.6/04/2014 Same as last inspection.11/12/2013 Same as last inspection.6/6/2013 Same as last inspection.10/31/2012 Pipe 3/4 full with soil on LS. FIELD_STRUCT_DESC: 24-inch (not 18-inch as shown in as-built drawings) corrugated metal drainage pipe through the levee, 6.7 feet below the crown. Concrete headwall at the landside (LS) toe. Flap gate on the waterside (WS). [Additional Reference(s): DWR Levee Logs, 1990. USACE As-Built Drawings 50-4-2637, Exhibit B, Sheet 2, April 1950 (Station 550+60)]. FS Date: 11/22/2016 10:19:47 AM

Flap gate at WS toe.

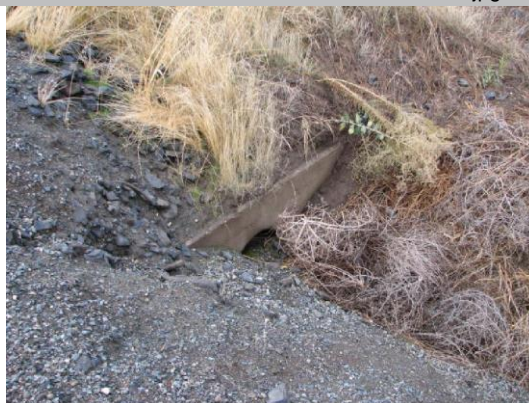
Photo 2 of 2 : UCIP_SP_2017_50930_68128.jpg

Comment Code						
Inspector Comment						
FS_ID:50930 DS_ID:1656 EP_NO: N/A Repair Type: Non-Urgent Crossing Status: Found UCIP Comments: 11/14/2016 LS inlet almost completely full of soil. (DWR Sutter Yard- A Freitag)5/23/2016 LS end is almost completel full of soil.7/28/2015 Pipe is still over 3/4 full of soil. 11/24/2014 Same as last inspection.6/04/2014 Same as last inspection.11/12/2013 Same as last inspection.6/6/2013 Same as last inspection.10/31/2012 Pipe 3/4 full with soil on LS. FIELD_STRUCT_DESC: 24-inch (not 18-inch as shown in as-built drawings) corrugated metal drainage pipe through the levee, 6.7 feet below the crown. Concrete headwall at the landside (LS) toe. Flap gate on the waterside (WS). [Additional Reference(s): DWR Levee Logs, 1990. USACE As-Built Drawings 50-4-2637, Exhibit B, Sheet 2, April 1950 (Station 550+60)]. FS Date: 11/22/2016 10:19:47 AM

Concrete headwall on LS toe.

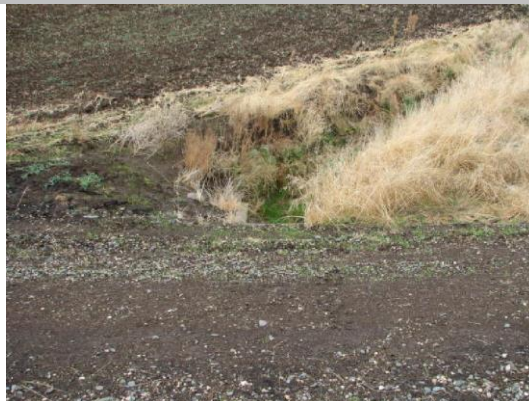
Photo 1 of 3 : UCIP_SP_2017_50937_68394.jpg

FS_ID:50937
DS_ID:1662
EP_NO: N/A
Repair Type: No Action Needed
Crossing Status: Found
UCIP Comments: 11/14/2016 Crossing appears to be in good condition. (DWR Sutter Yard- A Freitag) 5/12/2016 Crossing appears to be in good condition. 7/30/2015 Crossing is in good condition. No noticeable issues to report. 11/24/2014 Same as last inspection. 6/4/2014 Same as last inspection. 11/13/2013 Same as last inspection. 6/6/2013 Same as last inspection.
FIELD_STRUCT_DESC: 30-inch corrugated metal drainage pipe through the levee, 16.3 feet below the crown. Flap gate on the waterside (WS). Concrete "U" shaped headwalls on both the landside (LS) and the WS. [Additional Reference(s): DWR Levee Logs, 1990. USACE Sacramento O&M Manual 516, April 1960 (Station 374+90). USACE As-built Drawings 50-4-3367, Exhibit B, Sheet 13, April 1957 (Station 374+90)].
FS Date: 11/22/2016 10:35:19 AM

Concrete inlet on LS toe.

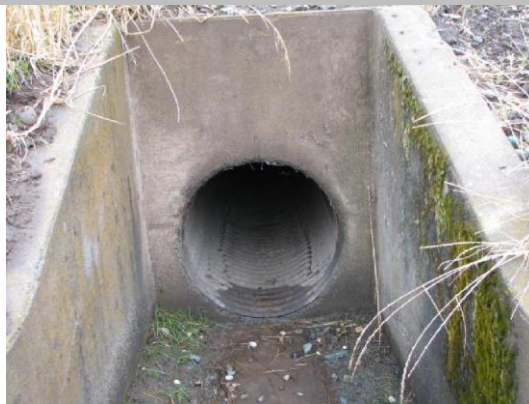
Photo 2 of 3 : UCIP_SP_2017_50937_68393.jpg

Concrete inlet on LS toe.

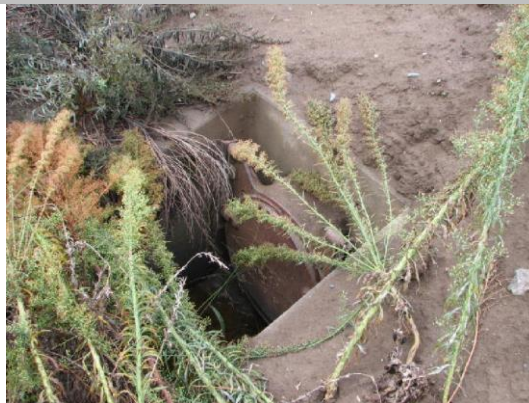
Photo 3 of 3 : UCIP_SP_2017_50937_68392.jpg

FS_ID:50937
DS_ID:1662
EP_NO: N/A
Repair Type: No Action Needed
Crossing Status: Found
UCIP Comments: 11/14/2016 Crossing appears to be in good condition. (DWR Sutter Yard- A Freitag) 5/12/2016 Crossing appears to be in good condition. 7/30/2015 Crossing is in good condition. No noticeable issues to report. 11/24/2014 Same as last inspection. 6/4/2014 Same as last inspection. 11/13/2013 Same as last inspection. 6/6/2013 Same as last inspection.
FIELD_STRUCT_DESC: 30-inch corrugated metal drainage pipe through the levee, 16.3 feet below the crown. Flap gate on the waterside (WS). Concrete "U" shaped headwalls on both the landside (LS) and the WS. [Additional Reference(s): DWR Levee Logs, 1990. USACE Sacramento O&M Manual 516, April 1960 (Station 374+90). USACE As-built Drawings 50-4-3367, Exhibit B, Sheet 13, April 1957 (Station 374+90)].
FS Date: 11/22/2016 10:35:19 AM

Concrete outlet and flap gate on WS toe.

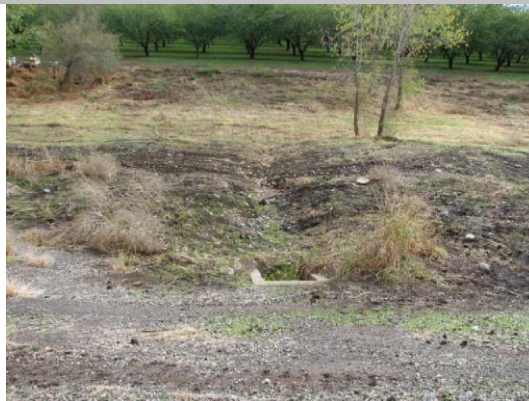
Photo 1 of 3 : UCIP_SP_2017_50940_68406.jpg

FS_ID:50940
DS_ID:1664
EP_NO: N/A
Repair Type: Non-Urgent
Crossing Status: Found
UCIP Comments: 11/14/2016 LS slide gate still missing. Rest of crossing appears in good condition. (DWR Sutter Yard-AFreitag)5/12/2016 LS inlet was unburied. Slide gate still missing7/30/2015 LS inlet is still buried.11/24/2014 Same as last inspection.6/4/2014 Same as last inspection.11/13/2013 Same as last inspection.6/6/2013 Same as last inspection.11/01/2012 LS inlet is buried under soil and covered with brambles. Slide gate missing from LS.
FIELD_STRUCT_DESC: 24-inch corrugated metal drainage pipe through the levee, 12 feet below the crown. Flap gate on the waterside (WS). Concrete headwall on the WS. Concrete headwall on the landside (LS), not found. [Additional Reference(s): DWR Levee Logs, 1990. USACE Sacramento O&M Manual 516, April 1960 (Station 338+04). USACE As-built Drawings 50-4-3367, April 1957, Exhibit B, Sheet 11 (Station 338+04)].

WS outlet and concrete U shaped headwall.

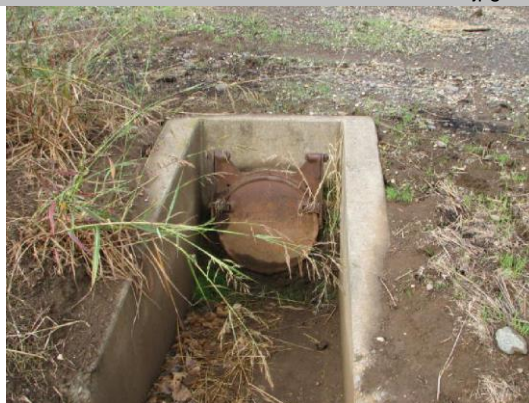
Photo 3 of 3 : UCIP_SP_2017_50940_68403.jpg

Comment Code						
Inspector Comment						
FS_ID:50940 DS_ID:1664 EP_NO: N/A Repair Type: Non-Urgent Crossing Status: Found UCIP Comments: 11/14/2016 LS slide gate still missing. Rest of crossing appears in good condition. (DWR Sutter Yard-AFreitag)5/12/2016 LS inlet was unburied. Slide gate still missing7/30/2015 LS inlet is still buried.11/24/2014 Same as last inspection.6/4/2014 Same as last inspection.11/13/2013 Same as last inspection.6/6/2013 Same as last inspection.11/01/2012 LS inlet is buried under soil and covered with brambles. Slide gate missing from LS. FIELD_STRUCT_DESC: 24-inch corrugated metal drainage pipe through the levee, 12 feet below the crown. Flap gate on the waterside (WS). Concrete headwall on the WS. Concrete headwall on the landside (LS), not found. [Additional Reference(s): DWR Levee Logs, 1990. USACE Sacramento O&M Manual 516, April 1960 (Station 338+04). USACE As-built Drawings 50-4-3367, April 1957, Exhibit B, Sheet 11 (Station 338+04)]. FS Date: 11/22/2016 10:37:46 AM

Concrete U shaped headwall and flap gate at WS toe.

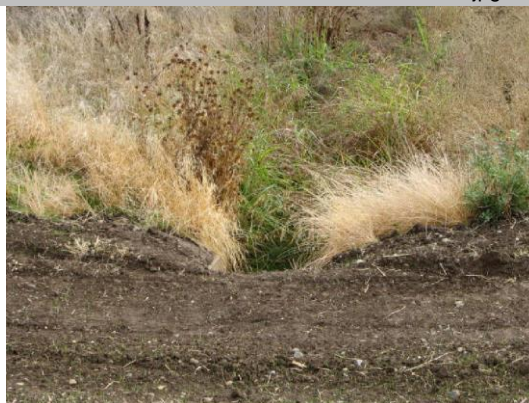
Photo 1 of 3 : UCIP_SP_2017_50941_68413.jpg

FS_ID:50941
DS_ID:1665
EP_NO: N/A
Repair Type: No Action Needed
Crossing Status: Found
UCIP Comments: 11/14/2016 Crossing appears to be in good condition. (DWR Sutter Yard- A Freitag) 5/12/2016 Crossing appears to be in good condition. 7/30/2015 Crossing appears in good condition. No noticeable issues to report. 11/24/2014 Same as last inspection. 6/4/2014 Same as last inspection. 11/13/2013 Same as last inspection. 6/6/2013 Same as last inspection.
FIELD_STRUCT_DESC: 24-inch corrugated metal drainage pipe through the levee, 11.3 feet below the crown. Flap gate on the waterside (WS). Concrete headwalls on both the landside (LS) and the WS. [Additional Reference(s): DWR Levee Logs, 1990. USACE Sacramento O&M Manual 516, April 1960 (Station 321+20)].
FS Date: 11/22/2016 11:46:50 AM

Concrete U shaped headwall and flap gate on WS toe.

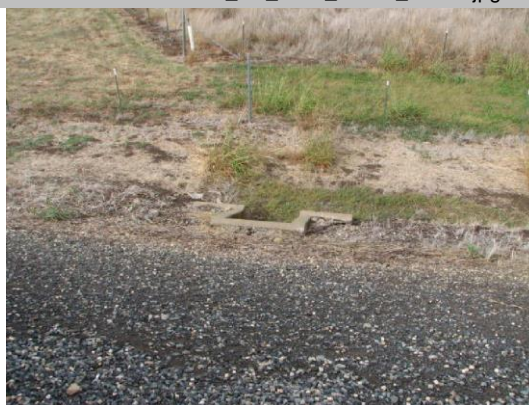
Photo 2 of 3 : UCIP_SP_2017_50941_68412.jpg

Concrete U shaped headwall on LS toe.

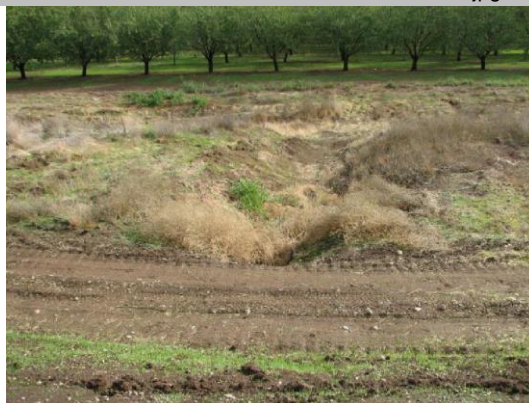
Photo 1 of 3 : UCIP_SP_2017_50942_68417.jpg

FS_ID:50942
DS_ID:1666
EP_NO: N/A
Repair Type: Non-Urgent
Crossing Status: Found
UCIP Comments: 11/14/2016 LS pipe inlet is half full of soil. WS flap gate shut but half buried by sediment. (DWR Sutter Yard-AFreitag)5/12/2016 Pipe is half full of soil.7/30/2015 Pipe is 1/4 to 1/2 full of soil still.11/24/2014 Same as last inspection.6/4/2014 Same as last inspection.11/13/2013 Same as last inspection.6/6/2013 Same as last inspection.11/01/2012 Pipe 1/2 filled with soil.
FIELD_STRUCT_DESC: 24-inch corrugated metal drainage pipe through the levee, 11.2 feet below the crown. Flap gate on the waterside (WS). Concrete "U" shaped headwalls on both the landside (LS) and the WS. [Additional Reference(s): DWR Levee Logs, 1990. USACE Sacramento O&M Manual 516, April 1960 (Station 304+10). USACE As-built Drawings 50-4-3367, April 1957, Exhibit B, Sheet 3 (Station 304+10)].
FS Date: 11/22/2016 12:04:57 PM

View of outlet looking toward WS toe.

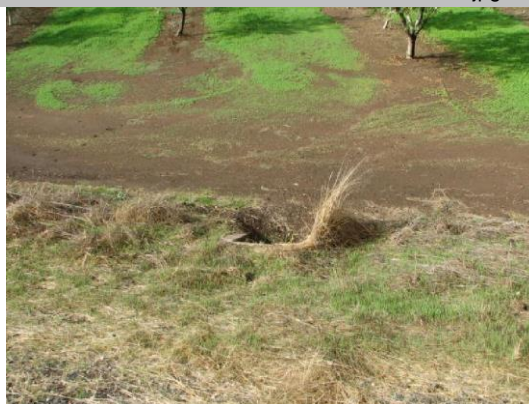
Photo 2 of 3 : UCIP_SP_2017_50942_68416.jpg

View of inlet on LS toe.

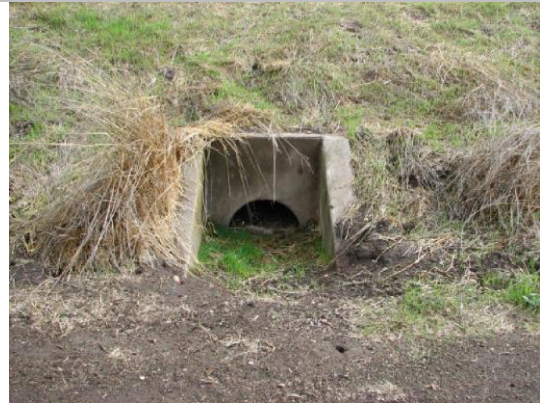
Photo 3 of 3 : UCIP_SP_2017_50942_68415.jpg

Comment Code						
Inspector Comment						
FS_ID:50942						
DS_ID:1666						
EP_NO: N/A						
Repair Type: Non-Urgent						
Crossing Status: Found						
UCIP Comments: 11/14/2016 LS pipe inlet is half full of soil. WS flap gate shut but half buried by sediment. (DWR Sutter Yard-AFreitag)5/12/2016 Pipe is half full of soil.7/30/2015 Pipe is 1/4 to 1/2 full of soil still.11/24/2014 Same as last inspection.6/4/2014 Same as last inspection.11/13/2013 Same as last inspection.6/6/2013 Same as last inspection.11/01/2012 Pipe 1/2 filled with soil.						
FIELD_STRUCT_DESC: 24-inch corrugated metal drainage pipe through the levee, 11.2 feet below the crown. Flap gate on the waterside (WS). Concrete "U" shaped headwalls on both the landside (LS) and the WS. [Additional Reference(s): DWR Levee Logs, 1990. USACE Sacramento O&M Manual 516, April 1960 (Station 304+10). USACE As-built Drawings 50-4-3367, April 1957, Exhibit B, Sheet 3 (Station 304+10)].

Concrete U-shaped headwall on LS toe.

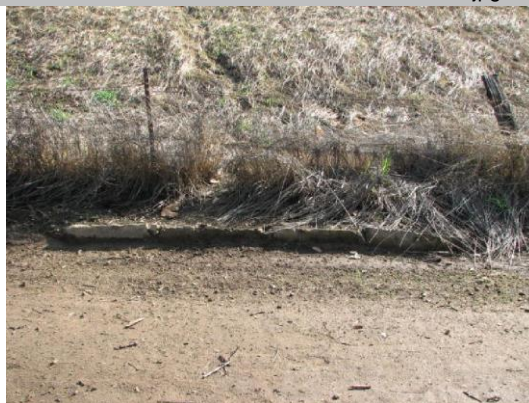
Photo 2 of 3 : UCIP_SP_2017_50950_68464.jpg

FS_ID:50950
DS_ID:1673
EP_NO: N/A
Repair Type: Non-Urgent
Crossing Status: Found
UCIP Comments: 11/14/2016 Abandoned- needs a cover for standpipe. (DWR Sutter Yard- A Freitag) 5/11/2016 Abandoned crossing. Needs a cover for the WS riser. 8/3/2015 Crossing appears abandoned. Only the slide gate inside riser on the WS shoulder could be found. Riser needs a cover made for it. 11/24/2014 Same as last inspection. 6/4/2014 Same as last inspection. 11/13/2013 Slide gate top and stem were repaired to make gate operational. 6/6/2013 New slidegate is planned to be installed during summer of 2013. 11/01/2012 Slide gate on WS shoulder bent and damaged (inoperable) Pipe appears abandoned.
FIELD_STRUCT_DESC: *ABANDONED* 24-inch corrugated metal drainage pipe through the levee, 14 feet below the crown. Slide gate in a corrugated metal riser on the waterside (WS) slope. [Additional Reference(s): DWR Levee Log, 1990. USACE Sacramento O&M Manual 516, April 1960 (Station 126+91)].

Abandoned headwall on LS toe.

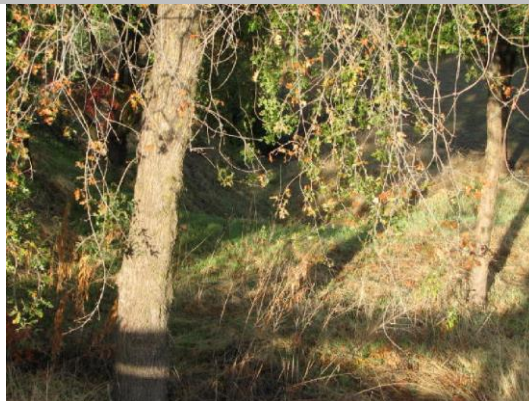
Photo 1 of 3 : UCIP_SP_2017_50960_68531.jpg

FS_ID:50960
DS_ID:1679
EP_NO: N/A
Repair Type: No Action Needed
Crossing Status: Found
UCIP Comments: 11/14/2016 Crossing appears to be in good condition. (DWR Sutter Yard- AFreitag)5/11/2016 Crossing appears to be in good condition.8/3/2015 Crossing appears in good condition. No noticeable issues to report.11/25/2014 Same as last inspection.6/4/2014 Same as last inspection.11/13/2013 Same as last inspection.6/6/2013 Same as last inspection.
FIELD_STRUCT_DESC: 24-inch corrugated metal drainage pipe through the levee, 14.5 feet below the crown. Concrete "U" shaped headwall on the waterside (WS). Flap gate on the WS. [Additional Reference(s): DWR Levee Logs, 1990. USACE Sacramento O&M Manual 516, April 1960 (Station 93+78)].
FS Date: 11/22/2016 1:05:24 PM

Inlet relocated after bridge replacement away from LS toe.

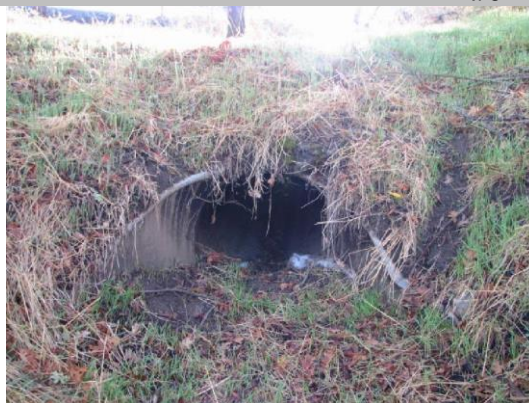
Photo 2 of 3 : UCIP_SP_2017_50960_68530.jpg

Inlet 50-feet NW of levee crown.

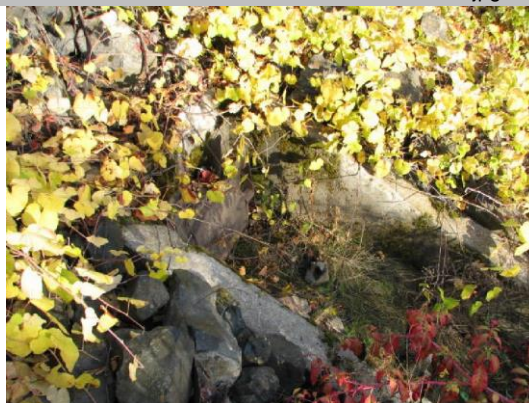
Photo 3 of 3 : UCIP_SP_2017_50960_68533.jpg

Item	DWR UCIP LMA Responsibility			39.678550 °	39.678550 °	
				-121.778339 °	-121.778339 °	
DWR ID						
Comment Code						
Inspector Comment						
FS_ID:50960 DS_ID:1679 EP_NO: N/A Repair Type: No Action Needed Crossing Status: Found UCIP Comments: 11/14/2016 Crossing appears to be in good condition. (DWR Sutter Yard- AFreitag)5/11/2016 Crossing appears to be in good condition.8/3/2015 Crossing appears in good condition. No noticeable issues to report.11/25/2014 Same as last inspection.6/4/2014 Same as last inspection.11/13/2013 Same as last inspection.6/6/2013 Same as last inspection. FIELD_STRUCT_DESC: 24-inch corrugated metal drainage pipe through the levee, 14.5 feet below the crown. Concrete "U" shaped headwall on the waterside (WS). Flap gate on the WS. [Additional Reference(s): DWR Levee Logs, 1990. USACE Sacramento O&M Manual 516, April 1960 (Station 93+78)]. FS Date: 11/22/2016 1:05:24 PM

Concrete U-shaped headwall and flap gate at WS slope.

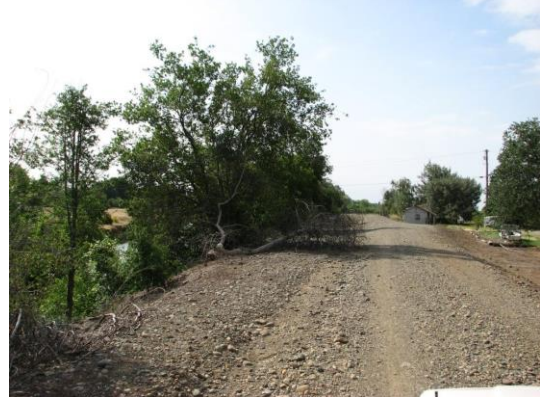
Photo 1 of 1 : SP_2017_MA0005_197_38_20170315_00014.jpg

LM Start	14.39	Rating **	M	Issue No.	38
LM End	14.39	Issue Type +	Ma	Location *	WS
Category	Earthen Levee			GPS Latitude/Longitude	
				Start	End
Item	Encroachments			39.692284 °	39.692284 °
				-121.779394 °	-121.779394 °
DWR ID	DWR_MA0005_02_s_2016_38				
Comment Code					
TR : Tree or limb					
Inspector Comment					
Fallen trees on W/S slope of levee.

5/5/2016: Remove fallen tree from W/S slope.

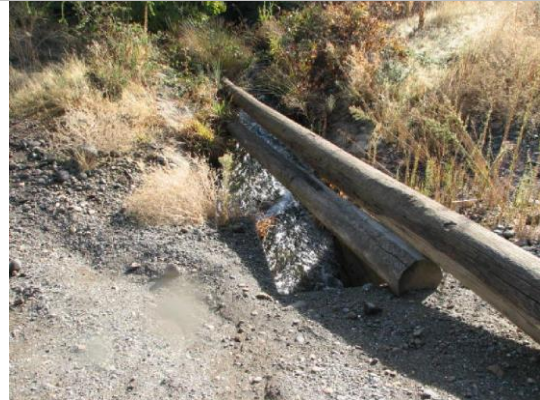
Photo 1 of 3 : UCIP_SP_2017_50963_68544.jpg

Comment Code					
Inspector Comment					
FS_ID:50963 DS_ID:1682 EP_NO: N/A Repair Type: No Action Needed Crossing Status: Found UCIP Comments: 11/14/2016 Crossing appears to be in good condition. (DWR Sutter Yard- A/Freitag)5/11/2016 Crossing appears to be in good condition.8/3/2015 Crossing appears in good condition. No noticeable issues to report.11/25/2014 Same as last inspection.6/4/2014 Same as last inspection.11/13/2013 Same as last inspection.6/6/2013 Same as last inspection. FIELD_STRUCT_DESC: 24-inch corrugated metal drainage pipe through the levee, 7.2 feet below the crown. Concrete "U" shaped headwall and grouted spillway on the waterside (WS). Slide gate in a 48-inch concrete standpipe on the landside (LS). Flap gate on the WS. [Additional Reference(s): DWR Levee Logs, 1990. USACE Sacramento O&M Manual 516, April 1960 (Station 37+10)]. FS Date: 11/22/2016 1:07:21 PM

Outlet at U-shaped headwall on WS toe.

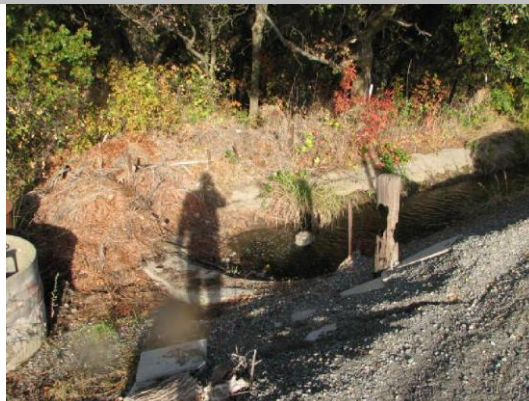
Photo 2 of 3 : UCIP_SP_2017_50963_68543.jpg

FS_ID:50963
DS_ID:1682
EP_NO: N/A
Repair Type: No Action Needed
Crossing Status: Found
UCIP Comments: 11/14/2016 Crossing appears to be in good condition. (DWR Sutter Yard- A Freitag) 5/11/2016 Crossing appears to be in good condition. 8/3/2015 Crossing appears in good condition. No noticeable issues to report. 11/25/2014 Same as last inspection. 6/4/2014 Same as last inspection. 11/13/2013 Same as last inspection. 6/6/2013 Same as last inspection.
FIELD_STRUCT_DESC: 24-inch corrugated metal drainage pipe through the levee, 7.2 feet below the crown. Concrete "U" shaped headwall and grouted spillway on the waterside (WS). Slide gate in a 48-inch concrete standpipe on the landside (LS). Flap gate on the WS.
[Additional Reference(s): DWR Levee Logs, 1990. USACE Sacramento O&M Manual 516, April 1960 (Station 37+10)].
FS Date: 11/22/2016 1:07:21 PM

Concrete lined channel on LS toe.

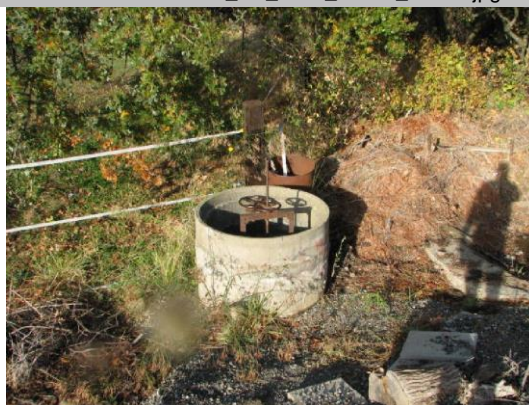
Photo 3 of 3 : UCIP_SP_2017_50963_68542.jpg

Concrete standpipe and slide gate on LS toe.

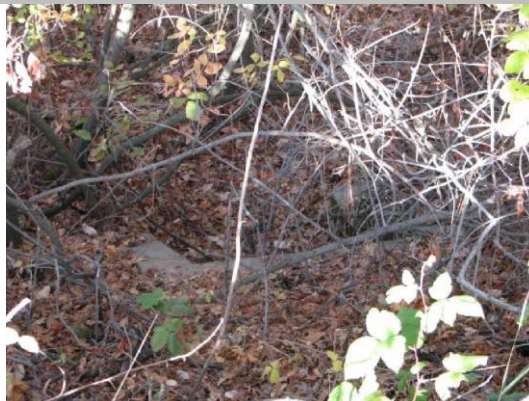
Photo 1 of 2 : UCIP_SP_2017_50964_68541.jpg

FS_ID:50964
DS_ID:1683
EP_NO: N/A
Repair Type: No Action Needed
Crossing Status: Found
UCIP Comments: 11/14/2016 Crossing appears to be in good condition. (DWR Sutter Yard- A Freitag) 5/11/2016 Crossing appears to be in good condition. 8/3/2015 Crossing appears in good condition. No noticeable issues to report. 6/6/2013 Same as last inspection. 11/13/2013 Same as last inspection. 6/4/2014 Same as last inspection. 11/25/2014 Same as last inspection.
FIELD_STRUCT_DESC: 24-inch corrugated metal drainage pipe through the levee, 14.3 feet below the crown. Concrete "U" headwalls on both the landside (LS) and the waterside (WS). Flap gate on the WS. Inlet downhill from a concrete lined channel at the low-point on the LS toe. [Additional Reference(s): DWR Levee Logs, 1990. USACE Sacramento O&M Manual 516, April 1960 (Station 36+85)].
FS Date: 11/22/2016 1:07:52 PM

Inlet at LS toe.

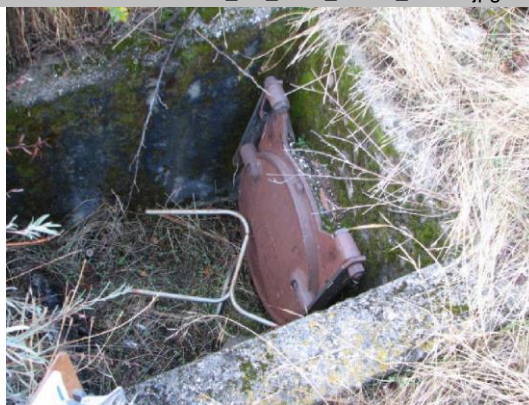
Photo 2 of 2 : UCIP_SP_2017_50964_68540.jpg

Outlet at WS toe with flap gate and concrete U-shaped headwall.

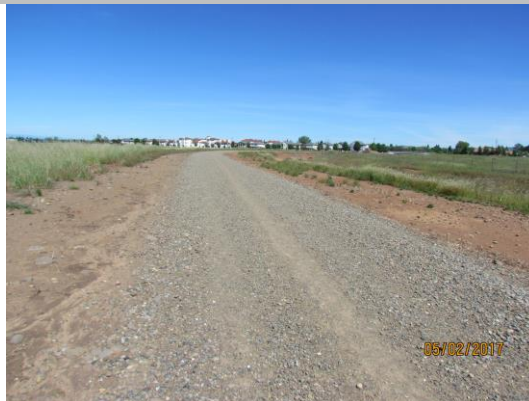
Photo 1 of 1 : SP_2017_MA0005_198_2_20170508_00001.jpg

LM Start	0.51	Rating **	A	Issue No.	2	
LM End	0.51	Issue Type +	Ma	Location *	LS	
Category	Earthen Levee			GPS Latitude/Longitude		
				Start	End	
Item	Vegetation			39.723773 °	39.723773 °	
				-121.780468 °	-121.780468 °	
DWR ID	DWR_MA0005_03_s_2017_2					
Comment Code						
V1 : Control annual grass and weeds on the levee slopes and easements.						
Inspector Comment						
The vegetation was removed from both slopes.

View of no vegetation on both slopes.
